Continued Operation of a 25-Raingage Network for Collection, Reduction, and Analysis of Precipitation Data for Lake Michigan Diversion Accounting: Water Year 2014

Nancy E. Westcott

February 2015

FINAL REPORT

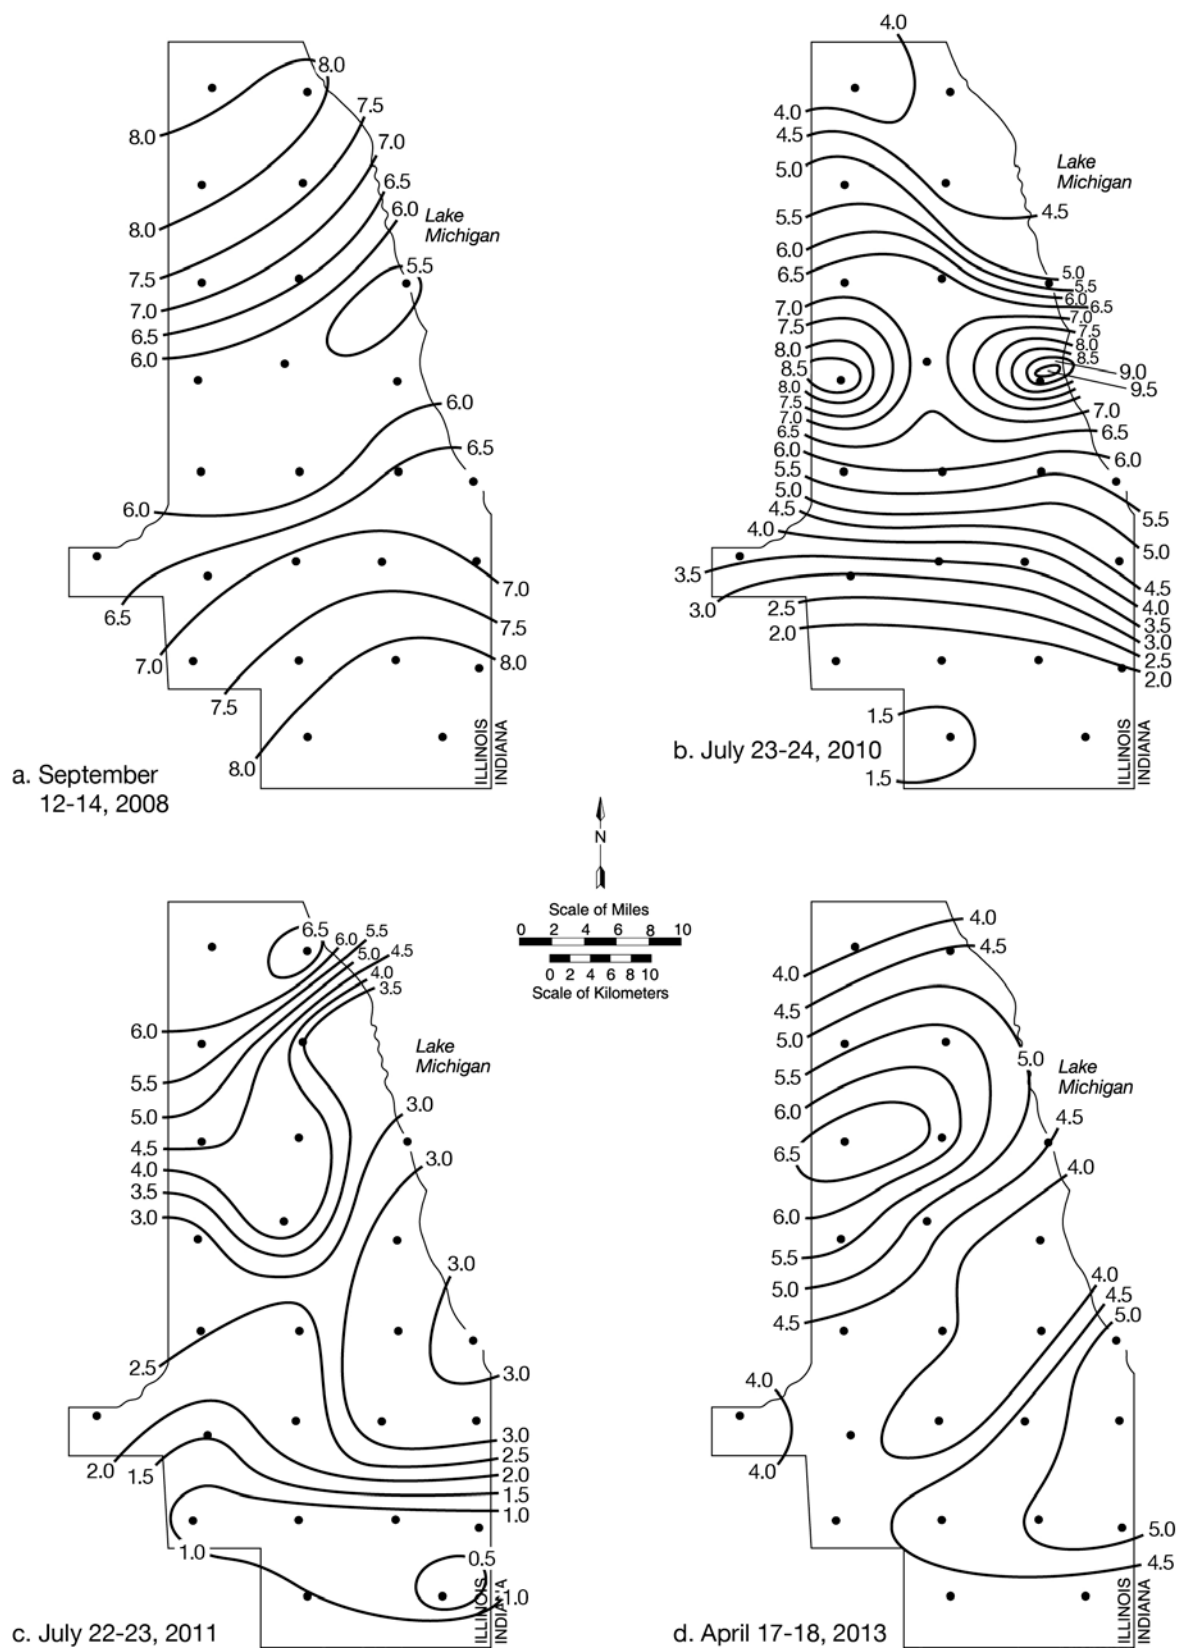
Figure IV-1. The four most intense storm events during Water Years 2008-2014.

The heavy precipitation events of Water Year 2014 occurred during the months of May through October, and generally were of short duration. The event with a gage with a return frequency of 25 years occurred on August 4, 2014, and the event with a gage exceeding a frequency return interval of 50 years occurred on August 21-22, 2014. Appendix IV contains specific information concerning the Water Year 2014 precipitation events for gages that exceeded the 1-year recurrence interval. It also presents information concerning the four largest storm events that occurred in Cook County during the period October 2007 to September 2014.
